**RE: Redevelopment Cost Estimate for:
 Rockford Paperboard, Inc. Property
 7700 Childsdale Avenue, NE
 Plainfield Township, Kent County, Michigan
 DEC Project No: 10-06-008b**

REDEVELOPMENT COST ESTIMATE

FIGURE 1 - PROPERTY/BUILDING DETAIL DIAGRAM

ROCKFORD PAPERBOARD PROPERTY
7700 CHILDSDALE AVENUE, NE
PLAINFIELD TOWNSHIP, KENT COUNTY, MICHIGAN

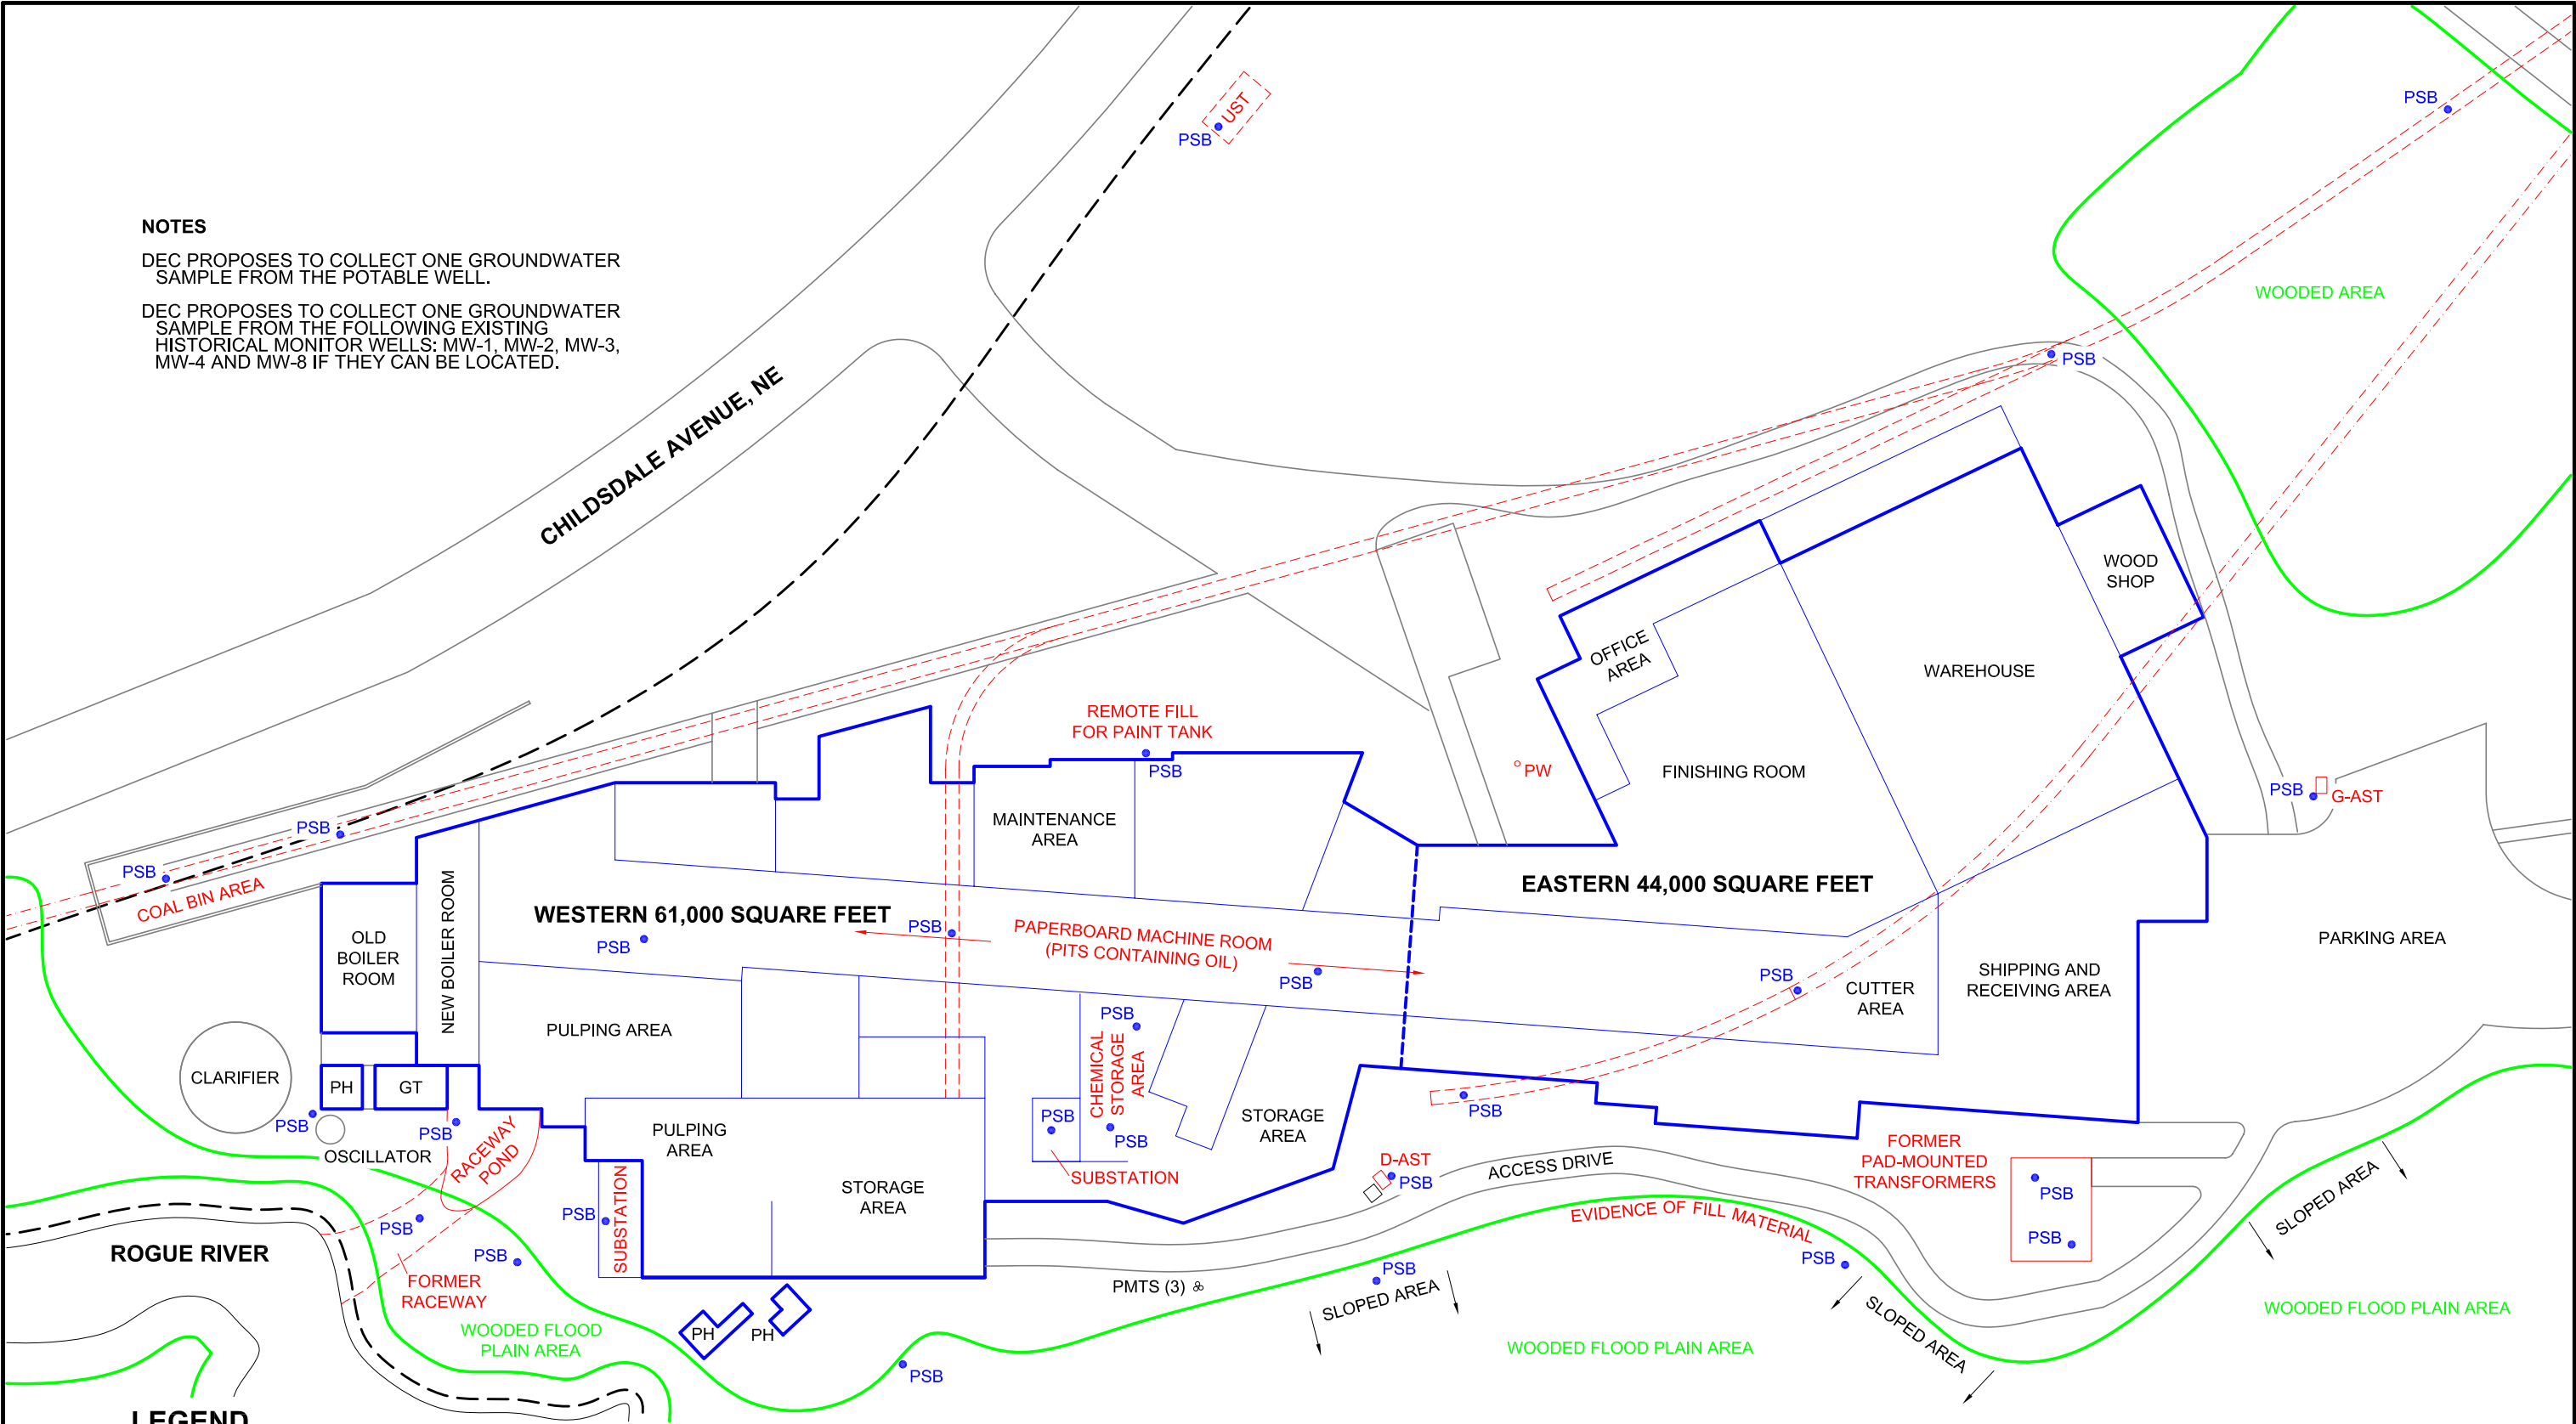
DEC PROPOSES TO COLLECT ONE GROUNDWATER SAMPLE FROM THE POTABLE WELL.

DEC PROPOSES TO COLLECT ONE GROUNDWATER SAMPLE FROM THE FOLLOWING EXISTING HISTORICAL MONITOR WELLS: MW-1, MW-2, MW-3, MW-4 AND MW-8 IF THEY CAN BE LOCATED.

NOTES:
THIS DIAGRAM IS NOT A LEGAL SURVEY.
FEATURES IN RED DENOTE
RECOGNIZED ENVIRONMENTAL
CONDITIONS.
